**AFRL-RW-EG-TR-2009-7093**

# **Attempts to Create Ball Lightning from Triggered Lightning**

**Department of Electrical and  
Computer Engineering  
University of Florida  
Gainesville, Florida 32611**

**Final Report For Period June 2007 – August 2009**

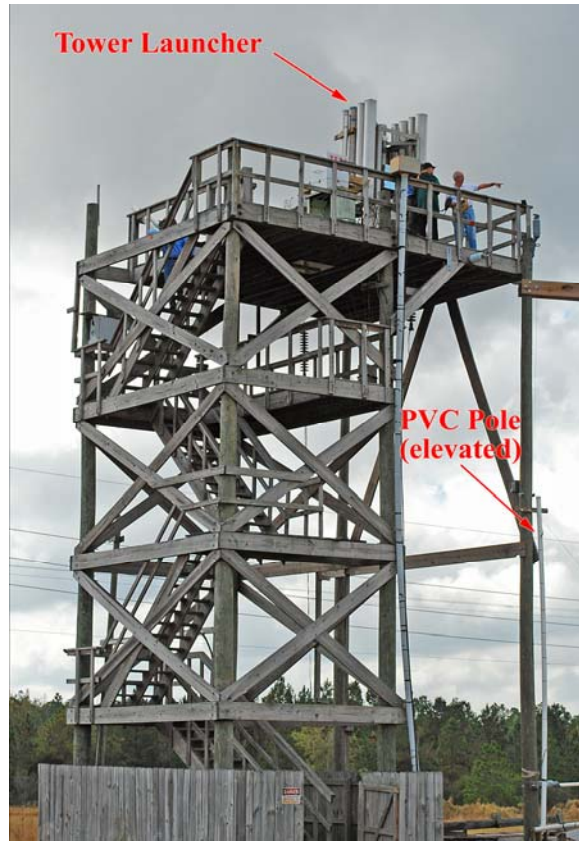
Figure 1. Full View of Launch Tower and Initial Ball Lightning Setup

The tower rocket launching facility is shown in Figure 1. Rockets trailing ground wires are launched from twelve aluminum launching tubes on the top of the 11 m tower. The current of a typical rocket-and-wire triggered lightning is comprised of two distinct sequential current intervals or phases. The first is the Initial Stage (IS). The Initial Stage is composed of an upward positive leader (UPL) current followed by an Initial Continuing Current (ICC). The ICC typically flows for some hundreds of milliseconds following the initiation of an upward positive leader from the tip of the ascending triggering wire (at an altitude of 100 to 300 m) and the subsequent connection of that leader with the cloud charge overhead (at perhaps 7 km). The Initial Stage current is typically relatively low in current amplitude, from less than a hundred amperes to several kilo-amperes. Following the UPL current and the ICC, during which the triggering wire is destroyed (typically about 10 ms after initiation of the UPL), the second phase of the triggered lightning occurs consisting of one or more dart-leader/return stroke sequences that typically traverse the remains of the channel left by the ICC. Return stroke (RS) currents for rocket-triggered lightning are impulsive (rise times of less than 1  $\mu\text{s}$ ) and average 10-15 kilo-amperes in peak amplitude. Return strokes are sometimes followed by continuing currents of hundreds of amperes with a duration of tens to hundreds of milliseconds, not unlike the ICC.

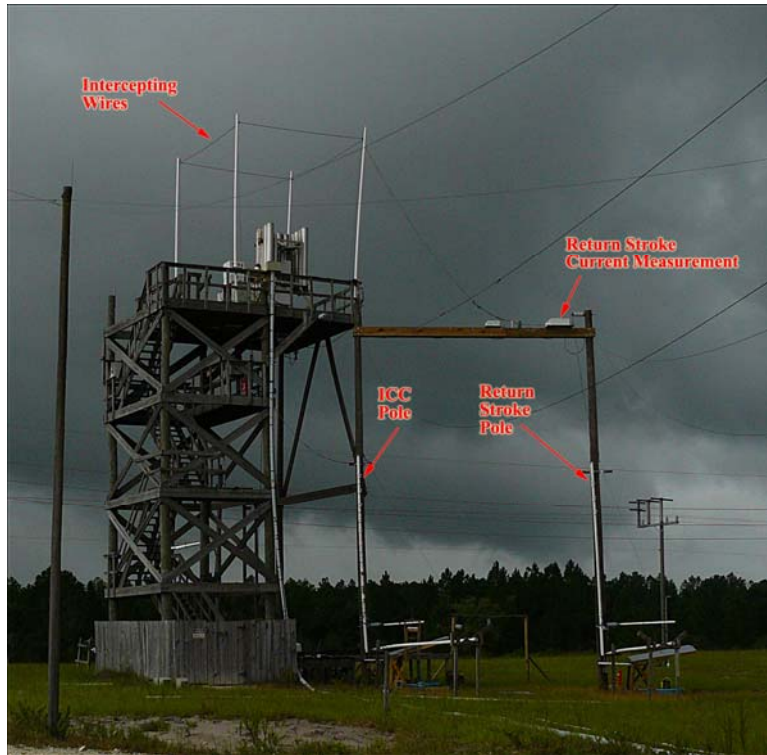
**Figure 3. Final Ball Lightning Setup**

The second physical configuration of the ball lightning experiment was completed on June 15, 2008 (see Figure 3). The goal of the second experimental setup was to separate the two current components, IS and RS, of the rocket-and-wire triggered lightning. This was accomplished by constructing an intercepting wire over the top of the tower launcher. Four 20 ft sections of 4 inch-diameter PVC supported a rectangle of  $\frac{3}{4}$  inch-galvanized pipe. While the IS current flows through the tower launcher on a path to ground as in the initial measurement setup, after vaporization of the triggering wire, subsequent dart-leader/return stroke sequences attach to the intercepting wire above the tower launcher from which the RS current is diverted to a separate path. The RS current was carried via braided wire to a second incident current measurement box positioned on top of a second telephone pole installed approximately 7.5 m west of the northwest tower support pole (pole to the right in Figure 3). A wooden crossbar was connected to the new pole to the tower for structural rigidity. A T&M Research R-5600-8 Current Viewing Resistor (shunt) was used to measure the RS current. The shunt has an internal resistance of  $0.00125\Omega$  and a 12 MHz bandwidth. Like the IS measurement, RS current waveforms were transmitted to the Launch Control trailer via Opticomm fiber-optic links and digitized on a Lecroy oscilloscope sampled at 100 MHz. An identical PVC pole, hinge mechanism, and pulley system was constructed and mounted on the new telephone pole for the

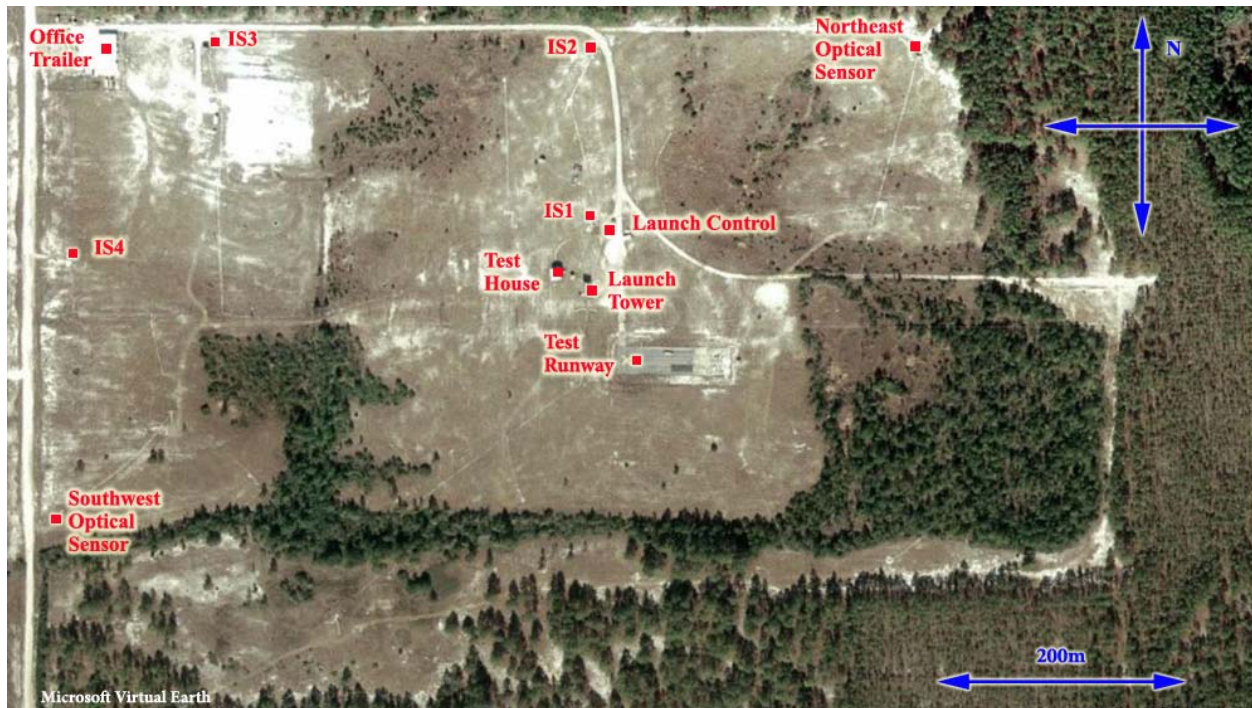
**Figure 4. Satellite View of the ICLRT Showing Structure Locations**

A satellite photograph showing the physical layout of the International Center for Lightning Research and Testing is shown in Figure 4. Structures described below are annotated in red type. Photographic data from the 2008 ball lightning experiment were acquired by a Phantom v7.0 High-Speed camera, four Sony HDR-HC5 high-definition video cameras, and four Nikon N2000 35 mm SLR cameras. The Phantom camera was operated from the Launch Control trailer located approximately 50 m north of the launch tower. The Phantom camera acquired data at a frame rate of 500 frames/sec (2 ms resolution) and was triggered at the time of the rocket launch. A Sony HD camera and Nikon 35 mm SLR also recorded the same field of view from the launch control trailer. In addition, Sony HD cameras were also placed in the Test House, Office Trailer, and Instrumentation Station 2 (IS2). Additional 35mm SLR cameras were placed in the Test House and in the Office Trailer. Each 35 mm camera was configured to take a 6 second time-exposure triggered at the time of the rocket launch. Two stacked ND4 neutral-density filters were used on all 35 mm cameras to prevent over-exposure.

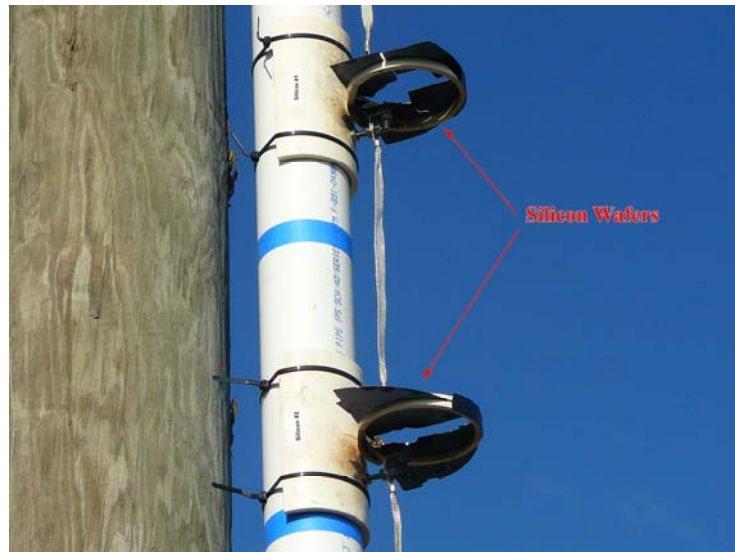
**Figure 6. Lightning-damaged Silicon Wafers**

The second interesting ball-lightning related event occurring during UF 08-02 resulted from the explosion of two silicon wafers (detailed material description in Appendix A) mounted on the PVC pole. A photograph of the lightning-damaged silicon wafers is shown in Figure 6, which, as noted earlier, also shows the braided wire offset from the PVC pipe and the spark gaps in the braided wire. The first silicon particles appear to erupt from the wafers approximately 212 ms after the full ignition of the triggering wire. However, the primary silicon particle shower did not begin until around 520 ms after the triggering wire fully ignited. The full duration of the silicon particle shower is approximately 3.35 s. However, most individual particles appeared to strike the ground between 0.75-1.25 s after being emitted from the lightning-struck silicon wafers. A picture showing ten extracted frames at 280 ms intervals, a total of 2.52 s, from the silicon particle shower is shown in Fig. 7. The first frame corresponds to a time 520 ms after the full ignition of the triggering wire. Most particles demonstrated relatively constant luminosity as they fell, and they also appeared to fall with reasonably constant acceleration. A video was created showing the luminosity from the falling silicon particles integrated over the full particle shower. The final frame from the video is shown in Figure 8 from which it is clear that the falling particles retained a constant luminosity, a characteristic reported for ball lightning. Velocity profiles were measured for numerous falling silicon particles, indicating that they fall under the influence of gravity. Additionally, individual particles are seen to deflect when they strike the structures below them and bounce when they impact the ground. A typical velocity profile is shown in Figure 9 with a linear regression line. Attempts were made to measure the sizes of various falling silicon particles from the Phantom video records with a known size

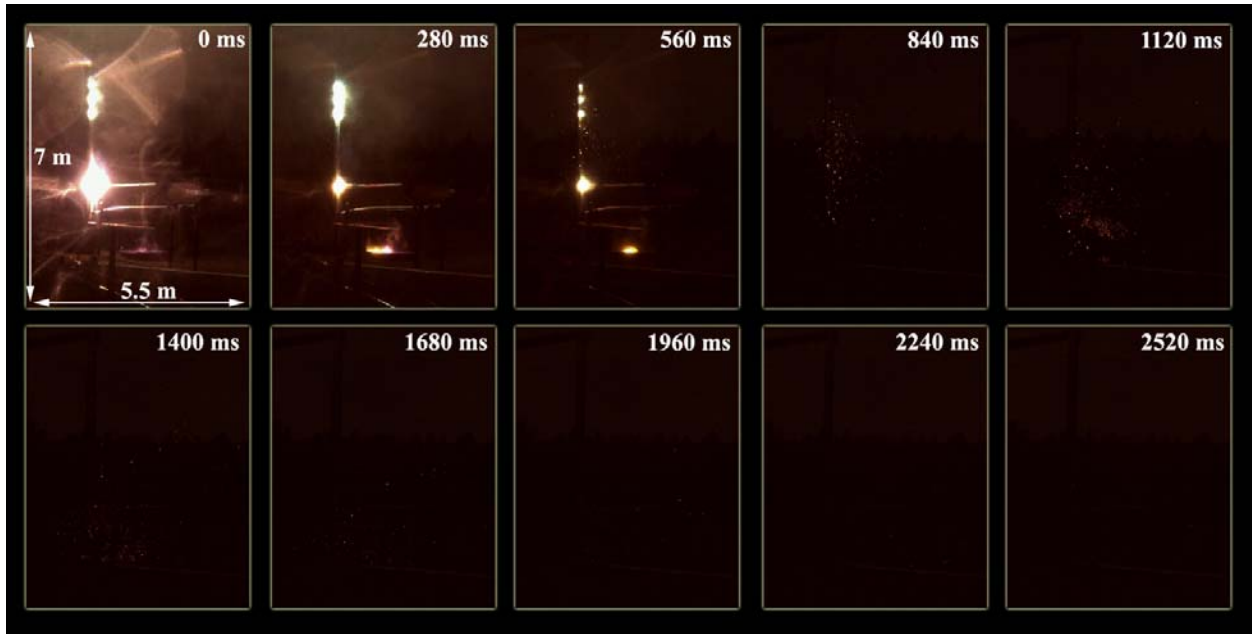
**Figure 7. Extracted Phantom video frames showing the silicon particle shower from UF 08-02**

reference point at the same distance from the lens. However, most of the particles were at most two pixels in size. With such poor resolution and blooming effects, the only statement that can be made regarding particle size is that most were likely less than 2 cm in extent (one pixel is approximately equal to 2 cm).

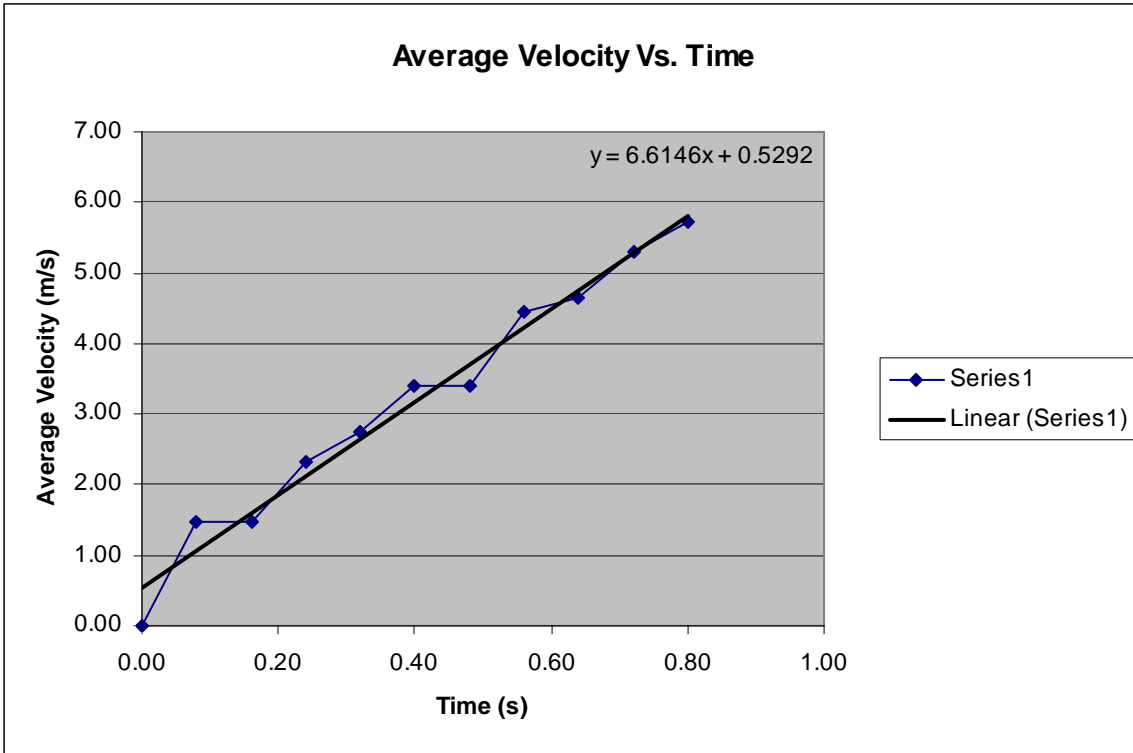
**Figure 9. Velocity Profile of Falling Silicon Particle**
